PRIMARY RECORD

*Resource Name or #: 528 N. Howard Ave.

*P11. Report Citation: Covina Town Center Historic Resource Survey prepared for City of Covina by Historic Preservation Partners (2006-7)

BUILDING, STRUCTURE, AND OBJECT RECORD

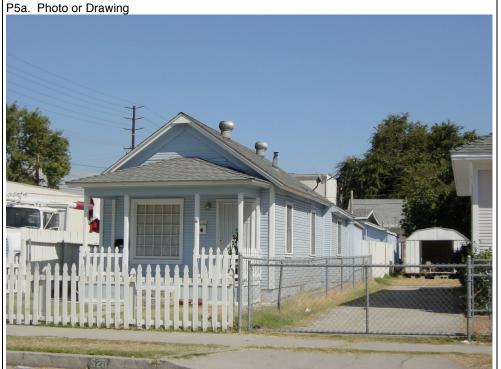
528 N. Howard Ave. is a shotgun house constructed in 1905, consisting of two improvements (according to the Los Angeles County Assessor). The first improvement is listed as being a 1 Bedroom/1 Bath consisting of 816 square feet and constructed in 1905. The second improvement is listed as a 1 Bedroom/1 Bath of 520 square feet also constructed in 1905. The house has a linear plan and front facing gable roof with full-width front porch. The house's most important character-defining feature is the linear plan, which is indicative of the shotgun architectural type. Other features include the clapboard siding, wood window casements, and wood windows. The house sits close to the street in a small residential and industrial area north of the downtown. The house appears to have had some alterations including the addition of a security door and fence pickets on the front porch. The property seems to be in fair to good condition.

P5b. Description of Photo: View E (10/2/06)

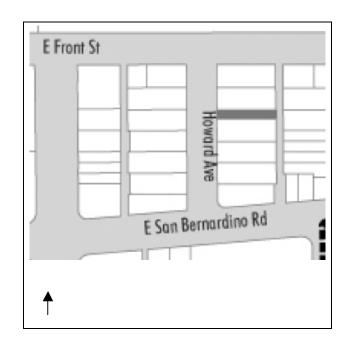
Note: 528 N. Howard is an example of a shotgun house that has not received significant alterations and retains historic integrity. 515 N. 1st Ave. is an example of a shotgun house that has received significant alterations that damage its historic integrity.
